project
CHIDDINGLY STREAM MILL BRIDGE

client
Chiddingly Parish Council, East Sussex

title
South Elevation

date	scale	drawn	checked	project	drawing	revision
Mar' 07	1:50	CP	SP	672	S.02	-

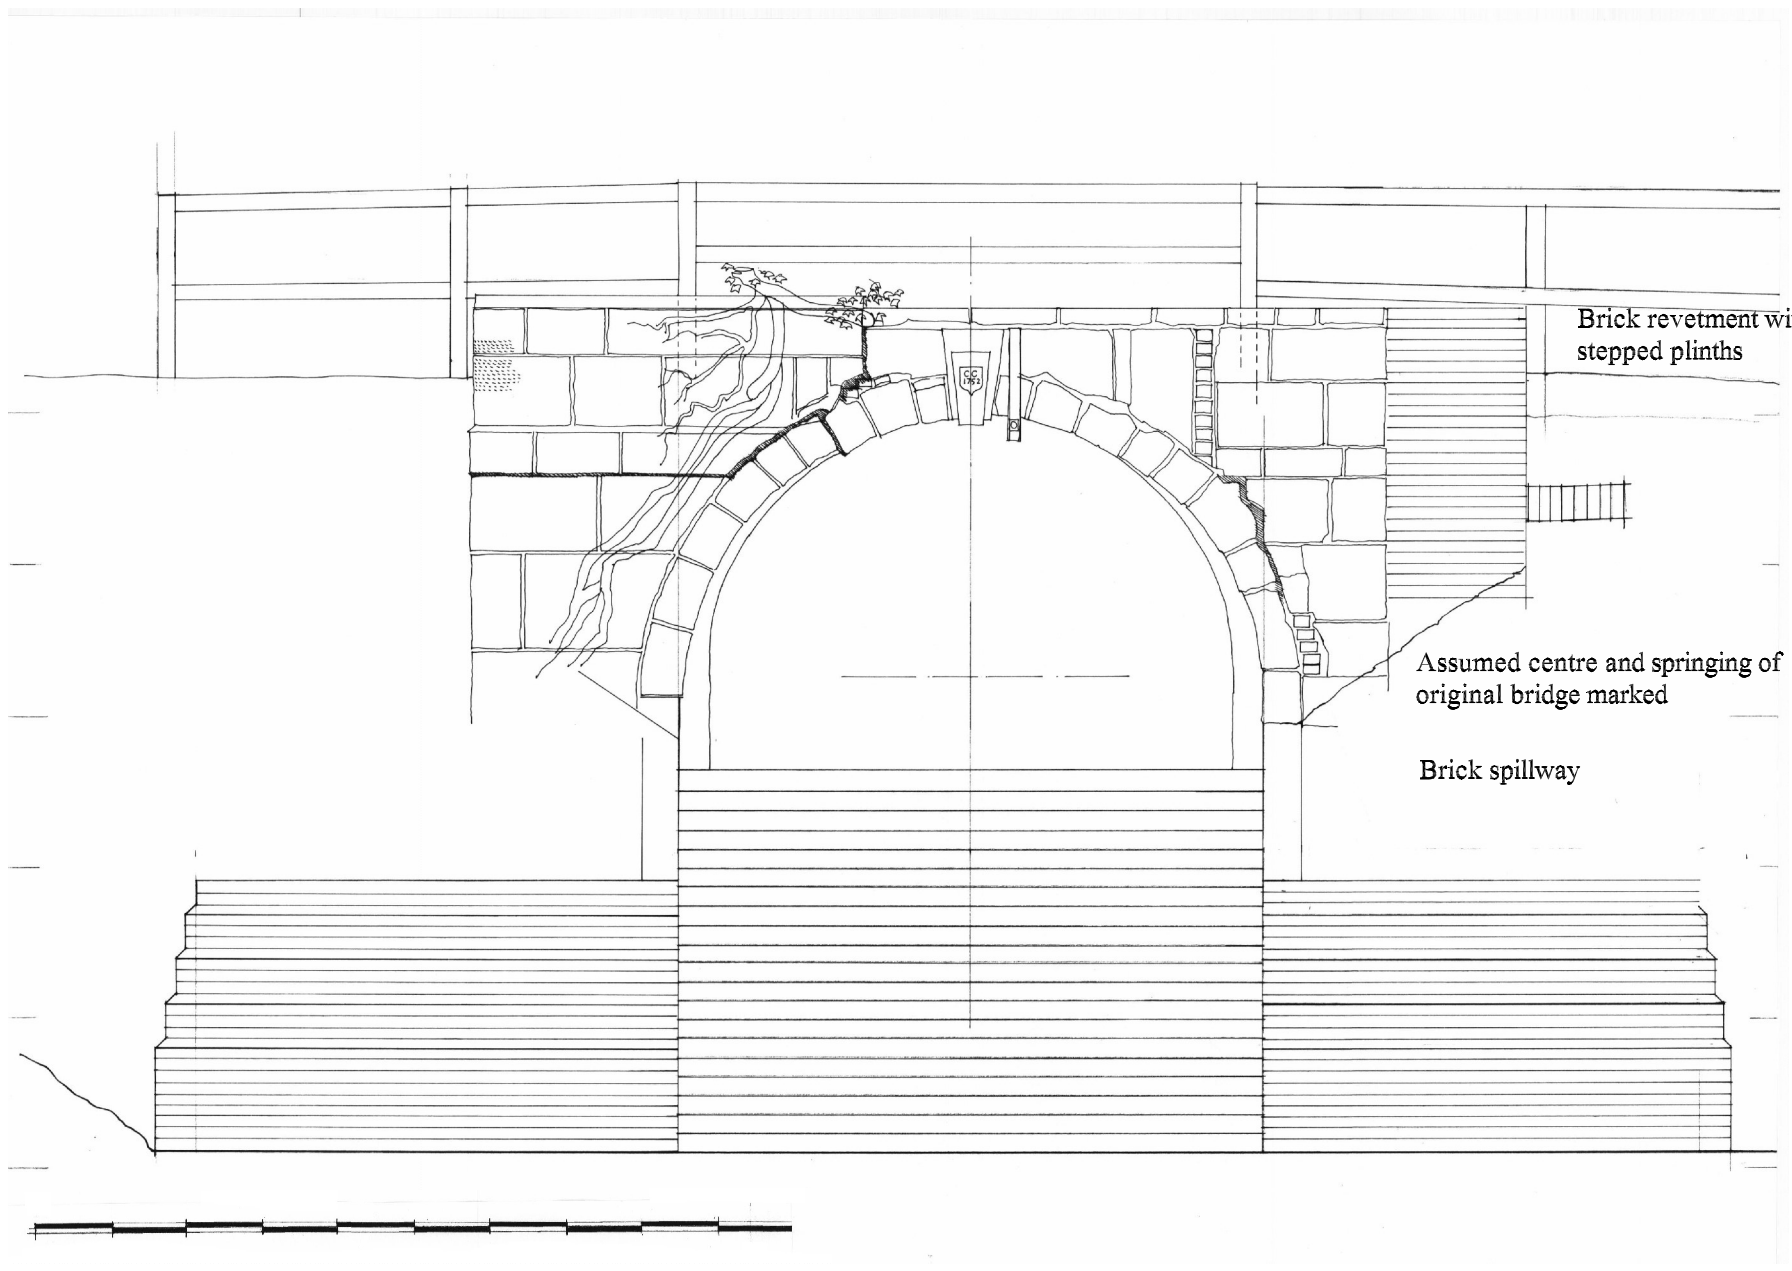
South Elevation

Stone coping varies in height

Areas obscured by close vegetation growing such as ivy -not drawn

Key voussoir inscribed cc 1752

Hatched areas are cavities formed by open joints or movement

Metal plate with bolted tie bar to opposite elevation

Silt depth may vary and stream bed depth not certain if to be taken when safe access has been provided

Earth bank retaining infill to causeway

Ivy growth to be cut as close as possible to masonry and allowed to die back

No herbicide to be used without prior consent of the Environment Agency

Test required when safe access is available to check depth and extent of any hard fill
